Naval Facilities Engineering Command

Abstract of an Accident

01-02

Accident Type: Crane

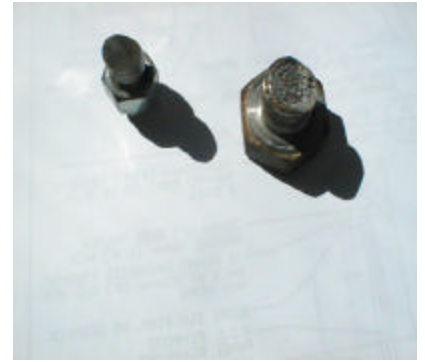
Pictures of sheared connecting bolts.

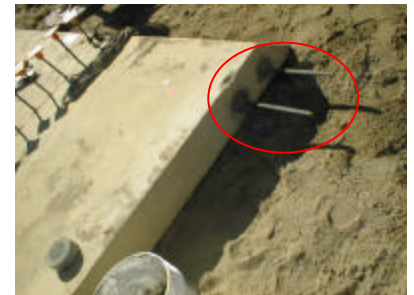
Dowels bent when load contacted ground.

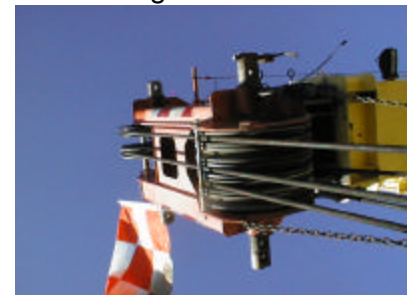
- ◆ Undersized Crane for lift due to inadequate planning.
- ◆ Overloading of the Auxiliary Hoist.
- ◆ Set Load Sensor to monitor main hoist, not the Whip

boom shows missing whip hoist "rooster head".

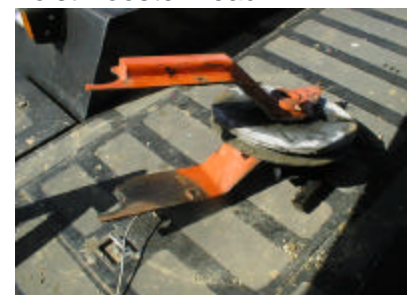
Damaged "rooster head".
